How to Repair Damaged PE-RT Pipe

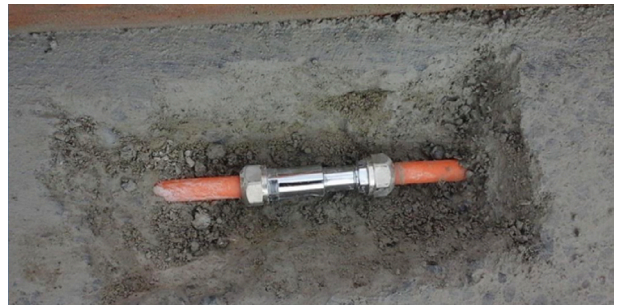
Option 1 - SKU: UFJRK1

When Multitubo PE-RT underfloor pipe is damaged in a slab there are a few methods to repair this;

1x telescopic joint and 2x PE-RT compression fittings. This would then be wrapped in denso tape, pressure tested, and the slab re-filled: Telescopic between 66mm & 95mm
